# Manhole Inspection Summary

## Manhole # S11KK1015MH

Insp Date: **5/31/07 10:17 AM**

**Location** Address: **3301 ROYCE AVE**

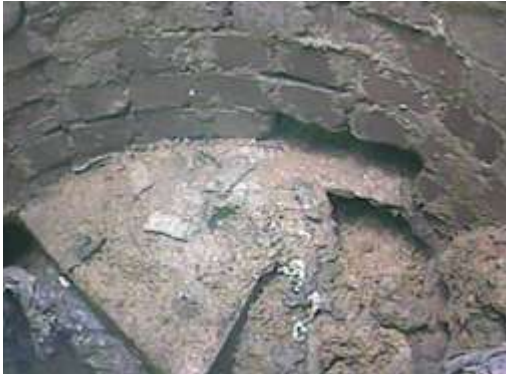
Defect 1

Condition: ☐ Sound ☐ Cracked ☐ Root Intrusion ☐ Loose Brick ☒ **Deteriorated**

Condition: ☐ Sound ☐ Cracked ☐ Root Intrusion ☐ Deteriorated ☐ Leaks ☒ **Debris**

BARREL DETERIORATION, LOOSE BRICK AND BENCH AND CHANNEL DEBRI

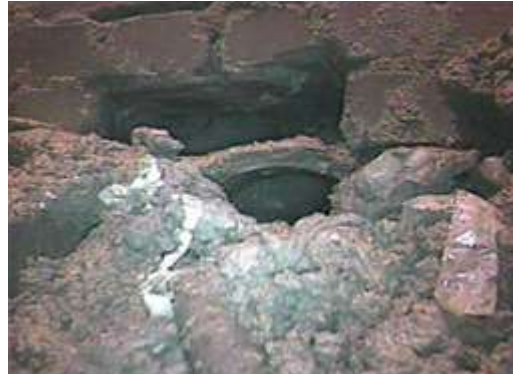
Defect 2

Condition: ☐ Sound ☐ Cracked ☐ Root Intrusion ☐ Deteriorated ☐ Leaks ☒ **Debris**

DEBRIS IN CHANNEL AND BARREL DETERIORATION

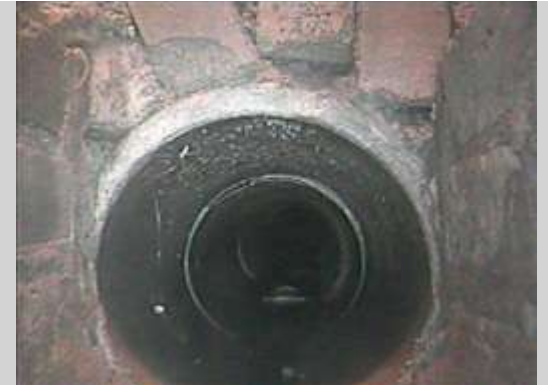
12 O'Clock Outflow

8 in. Circular Gravity Sewer  
Pipe Out @ 12 O'Clock

Pipe Height: (in.) Direct  
Pipe Material: **Clay** ☐ Pipe Lined  
Invert Depth: **9.47** (ft.) Flow Characteristics: **Slow**  
Deposits: ☒ None ☐ Mud ☐ Sludge ☐ **Debris** ☐ Grease  
Silt Depth: (in.) Deposits Extent:  
Infiltration: **None** Pipe Seal Cond: **Sound**

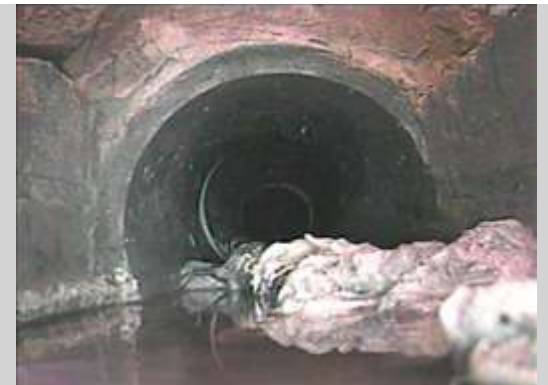
6 O'Clock Inflow

8 in. Circular Gravity Sewer  
Pipe In @ 6 O'Clock

Pipe Height: (in.) Direct  
Pipe Material: **Clay** ☐ Pipe Lined  
Invert Depth: **9.17** (ft.) Flow Characteristics: **Slow**  
Deposits: ☐ None ☐ Mud ☐ Sludge ☒ **Debris** ☐ Grease  
Silt Depth: **1.5** (in.) Deposits Extent: **Medium**  
Infiltration: **None** Pipe Seal Cond: **Sound**

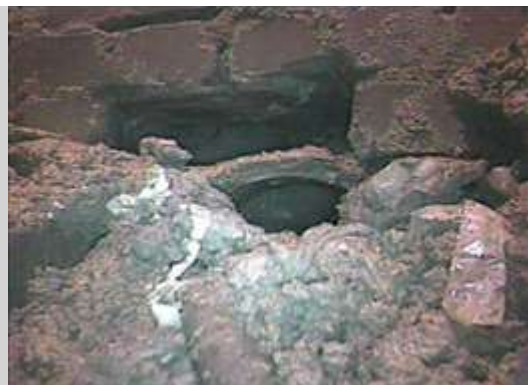
9 O'Clock Inflow

8 in. Circular Gravity Sewer  
Pipe In @ 9 O'Clock

Deposits: ☐ None ☐ Mud ☐ Sludge ☒ **Debris** ☐ Grease

Silt Depth: **8** (in.) Deposits Extent: **Heavy**

Infiltration: **None** Pipe Seal Cond: **Broken**

Connects To: **Stub connection / abandoned**
